NATIONAL ADVISORY COMMITTEE FOR AERONAUTICS

No. 710

TESTS FOR THE ELIMINATION OF TAIL FLUTTER
By Curt Biechteler

TECHNICAL MEMORANDUM NO. 710

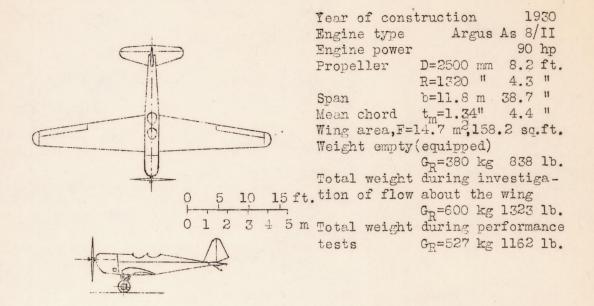
Figure 14.

The simplified fairing designed by Professor Madelung, of Stuttgart, is shown in figure 14. Its forward portion merely covers the angle between the wing and fuselage, while its after portion represents material increases in the thickness and chord of the wing section. The fairing of the lower surface of the wing, which forms a gradual transition to the bottom of the fuselage, is the same as used with fairing I.

FIGURE 14.- Wing-fuselage connection with fairing II. The form of the fairing can be developed geometrically. Its forward portion covers the angle between wing and fuselage, while the rear materially increases the thickness and chord of the wing section.

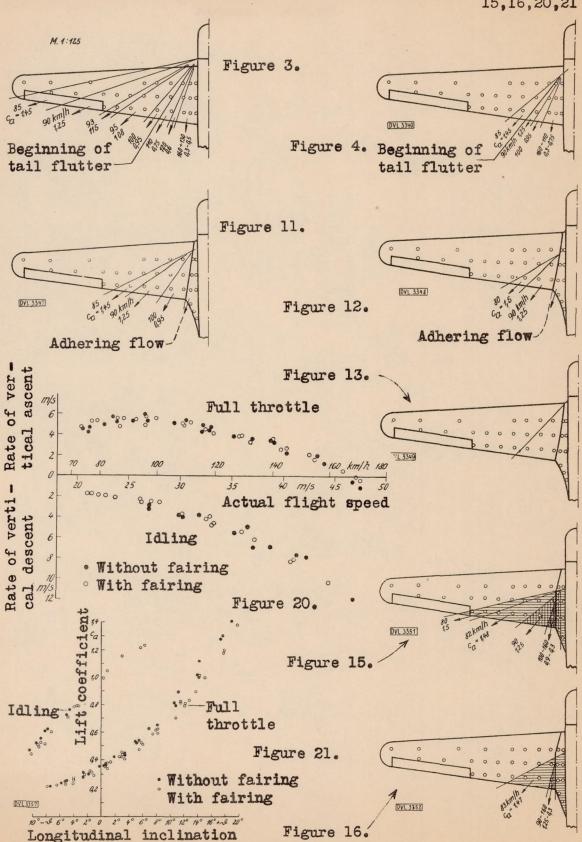
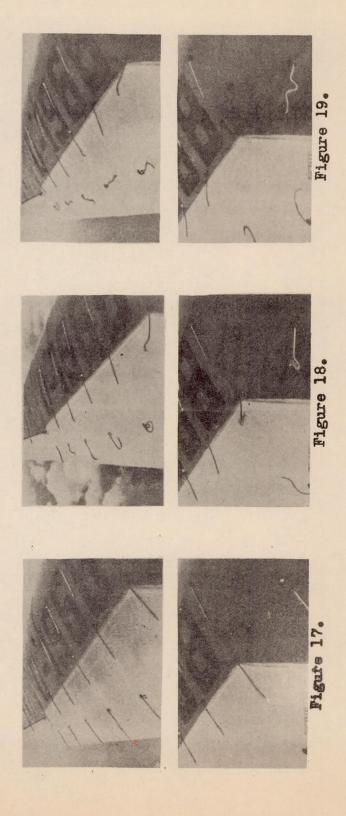
Figure 5. - Various means of preventing premature separation of the flow about the wing.

Various methods of preventing premature separation of the wing flow are outlined below (fig. 5):

- g) Blowing the boundary layer off the upper surface of the wing. Compressed air is blown through slots in the upper surface of the wing, as shown in figure 5,g. The effect on the flow about the wing is similar to the effect of suction.
